Fatigue Crack Growth in Several 7050T7451 Aluminium Alloy Thick Section Plates with Aircraft Manufacturer's and Laboratory Surface Finishes Representing Some Regions of the F / A-18 Structure

S. A. Barter DSTO-TR-1539

DSTO-TR-1539

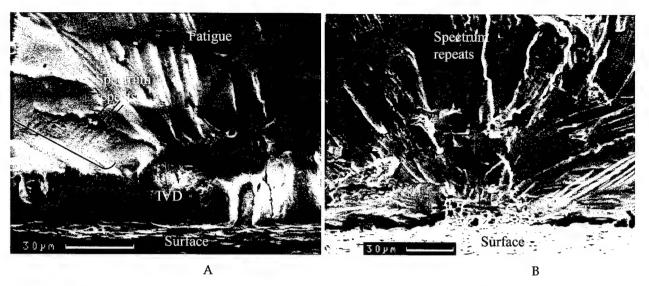
Close examination of the surfaces of the main cracks and many of the secondary cracks revealed that the growth pattern (for example Figure 8) was evident on not only the main crack but also the secondary cracks; except the spacing of the repeating patterns were compressed compared to that of the main cracks. To examine this, several of these cracks had their crack growth measured along with the main cracks (usually the larger secondary cracks). These results and an outline of the measuring method are presented in the next section.

Figure 8. The surface of two secondary cracks showing the repeating pattern caused by the marker loads in the applied loading spectrum. The position of these loads were measured in the quantitative fractography section that follows. A is from FT488/1 02 and B is from KW101. FT488/1 02 had 32 blocks of the spectrum applied while KW101 had 17 blocks applied.

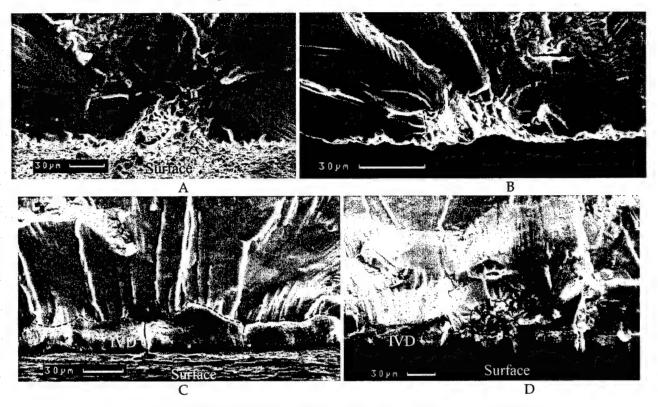
In the KW specimens, etch pits were generally either associated with grain boundaries and/or at etched out, or partially etched out inclusions. Examples of the cracking initiating from etch pits are shown in Figure 8 and Figure 9. In the Y488 bulkhead specimens, initiation was still plentiful from grain boundaries and/or at etched out, or partially etched out inclusions although the pitting appeared to be generally less deep, particularly in the FT488/2 specimens. These shallower pits appeared to be associated with machining marks that had been formed in the bulkhead surface during manufacture and then etched as part of the pre-IVD etching

Figure 9 Four examples of initiating flaws created by the etching found in both the KW, (A & B) and 488 bulkhead specimens, (C & D). A dashed line gives the approximate interface between the flaws and the beginning of the fatigue crack growth. The spectrum block repeats can be seen on the fatigue surface in some of these images.

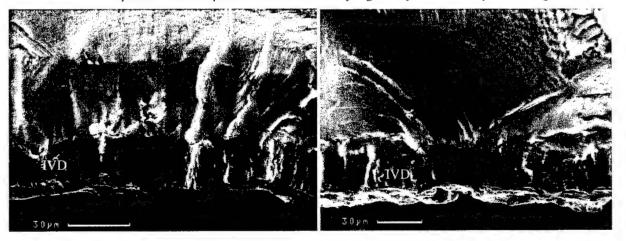
process. As a result shallow pits could be found to run in long groups at the base of these shallow machining marks. This lead to long groups of initiations that closely followed the machining marks. These features can be seen in two FT488/2 specimen fractures as shown in Figure 10.

Figure 10 The originating areas of two cracks from the FT488/2 specimens showing the many closely spaced origins and difficult to identify flaw depth, compared to the KW specimens etch pitting. These origins appear to be associated with lines of pits at the base of shallow machining marks.

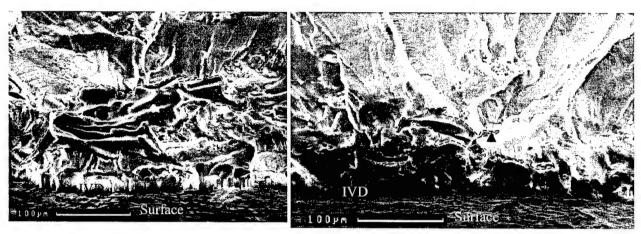
Two of the larger fatigue cracks from one specimen taken from the FT488/1 bulkhead (specimen 010 (420MPa peak stress)) had initiated from porosity as noted above. These pores were either slightly subsurface or touching the surface at the IVD/7050 interface. The life of this specimen did not appear to be significantly different to the other specimens tested at this stress level, although the porosity, particularly in one case was significantly larger than any etch pit found initiating a fatigue crack or otherwise. These two initiation sites are shown in Figure 11. It should be noted that a large number of crack initiation sites were examined during this part of the investigation; about 400, so the occurrence of porosity as an initiator was about 1 in 200 crack initiations in these specimens. It is unknown if this ratio is applicable to components although most of the specimens tested here had surfaces consistent with service component surfaces. Further assessment of service components is being carried out (Dixon and Molent, 2003) and will be reported on in the future.

Figure 11 Two crack originating areas from the FT488/1 10 specimen showing the many closely spaced origins around the porosity (outlined with the dashed lines) in the material. In the second example the dominant fatigue crack has started from the region marked with the arrow head.
